Andree Clark Bird Refuge Vegetation Maintenance and Restoration Project Biological Assessment

Project No. 30174232.00

City of Santa Barbara, Parks and Recreation Department

Biological Assessment

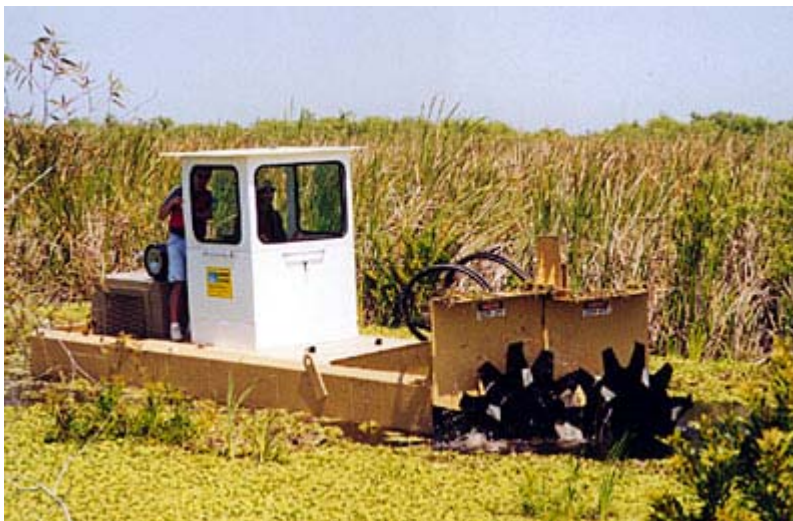
Figure 2-1. Cookie Cutter

The “cookie cutter” incrementally cuts/shreds emergent vegetation in sections above and below the water, including the root system, with two rotating wheels. Cutting will be performed by starting the shredding at the top of the tules/cattails and will make its way down to the plant rhizomes. The machine will cut into the soil only as far as needed to destroy the root zone. The machine moves perpendicular to the shoreline or along the pathway to be cleared and needs a water depth of at least 20 to 30 inches to float. When moving into a dense area of emergent

vegetation, the path created provides access. After a pass with the cookie cutter, the harvester comes in, scoops up the debris onto a conveyor belt, and shredded vegetation is unloaded at the shoreline for disposal. Figures 2-1 and 2-2 depict the cookie cutter and harvester, respectively.

The cookie cutter and harvester require a minimum of 20 to 30 inches of water in order to operate; therefore, work is proposed to begin after winter rains have increased the depth of the relatively shallow Refuge lake. This portion of the project is dependent upon environmental conditions, and aquatic vegetation cutting and harvesting is estimated to begin in January or
